# McDATA<sup>®</sup> Sphereon<sup>™</sup> 4300 Fabric Switch Installation and Service Manual P/N 620-000171-030 REV A

# Simplifying Storage Network Management

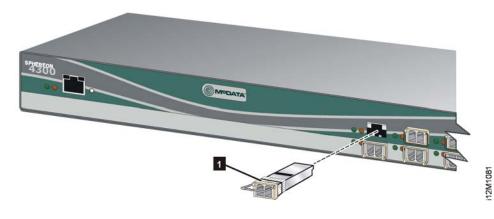
Figure 6-1 Front-Accessible FRUs

Figure 6-1 illustrates front-accessible FRUs. Table 6-1 is the associated FRU parts list. The table includes reference numbers to Figure 6-1, FRU part numbers, descriptions, and quantities.
